Some 2005 model year Chevy and GMC full size vans have been produced with large amounts of caulking in their roof gutters. This situation occurs when the bolts supplied, with the model numbers listed to the right, are too short as the caulk gap between the stand and mounting bracket increases. Both the new "Universal Clamp" and the "GM" style clamps are affected.

GUTTER CLAMP SPACER KIT

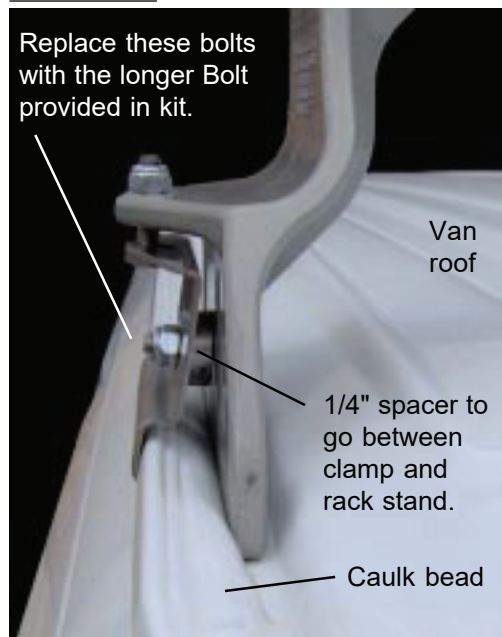
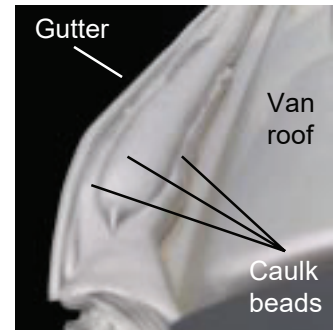
Using the longer bolts supplied in this kit, place the round 1/4" thick spacers between the gutter clamp and the ladder rack base. This will compensate for the thickness of the caulking in the gutter. In extreme cases, a portion of the caulk might have to be cut out of the gutter and then re-caulked after the rack is installed.

Mounting Kit #32-0134

Quantity	Description
4 ea.	5/16-18 x 1-1/4" Carr. Bolt
4 ea.	1/4" Spacer

Mounting Kit #32-0135

Quantity	Description
2 ea.	5/16-18 x 1-1/2" Hex. Hd. Bolt
2 ea.	1/4" Spacer
